Stormwater Asset Inventory and Condition Assessments to Support Asset Management

Session 12710

Ben Recker, Tetra Tech Inc.

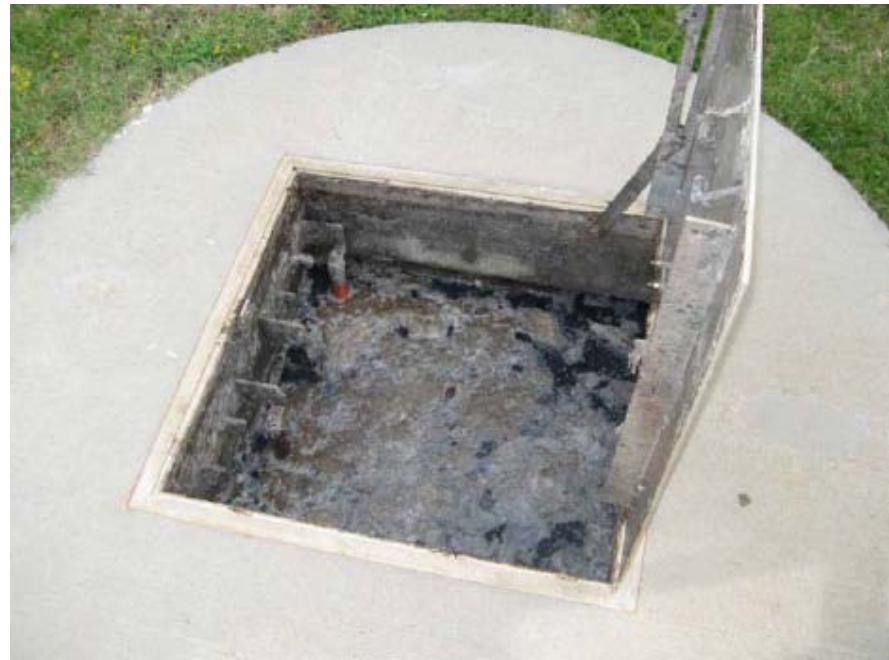
Surcharged lift station not included on maintenance contract

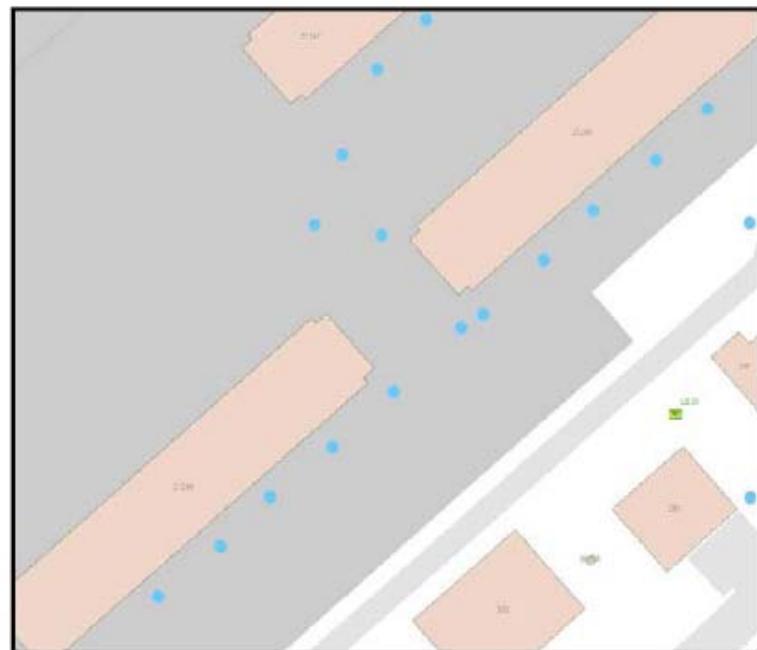
Before

Connectivity

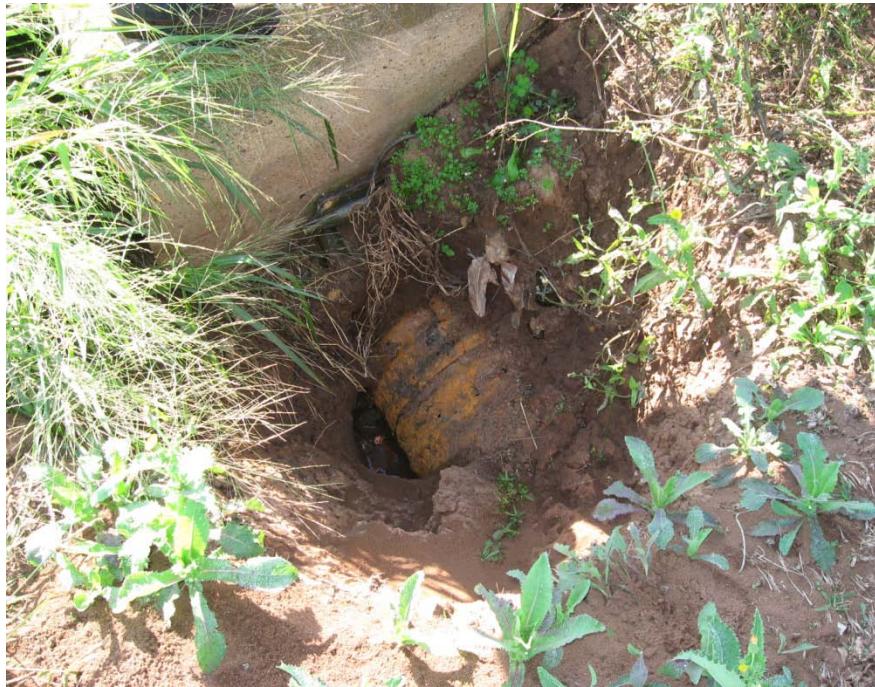
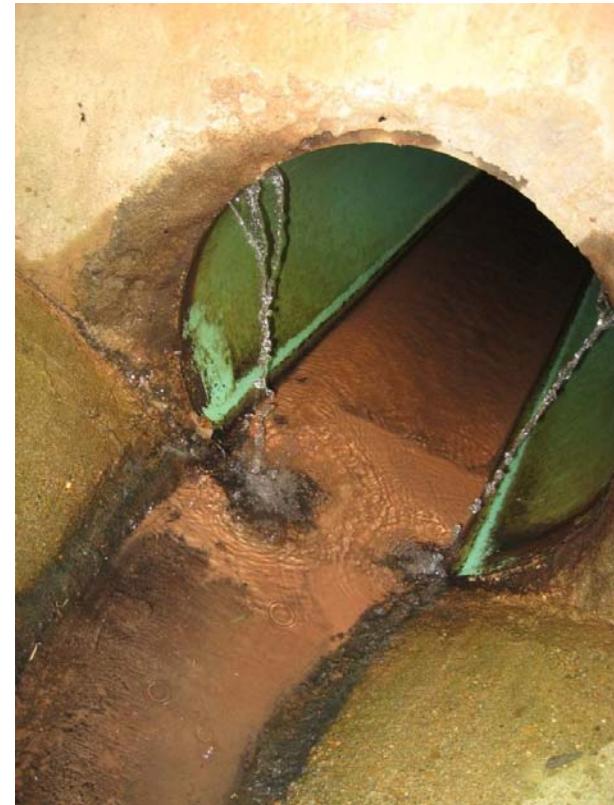
- ❖ Importance of Condition Assessment to identify and document system issues
